**GENERAL PHILIP SCHUYLER HOUSE**  
**HISTORIC STRUCTURE REPORT**

**Saratoga National Historical Park  
Schuylerville, New York**

**Volume 1 of 2**

**2003**

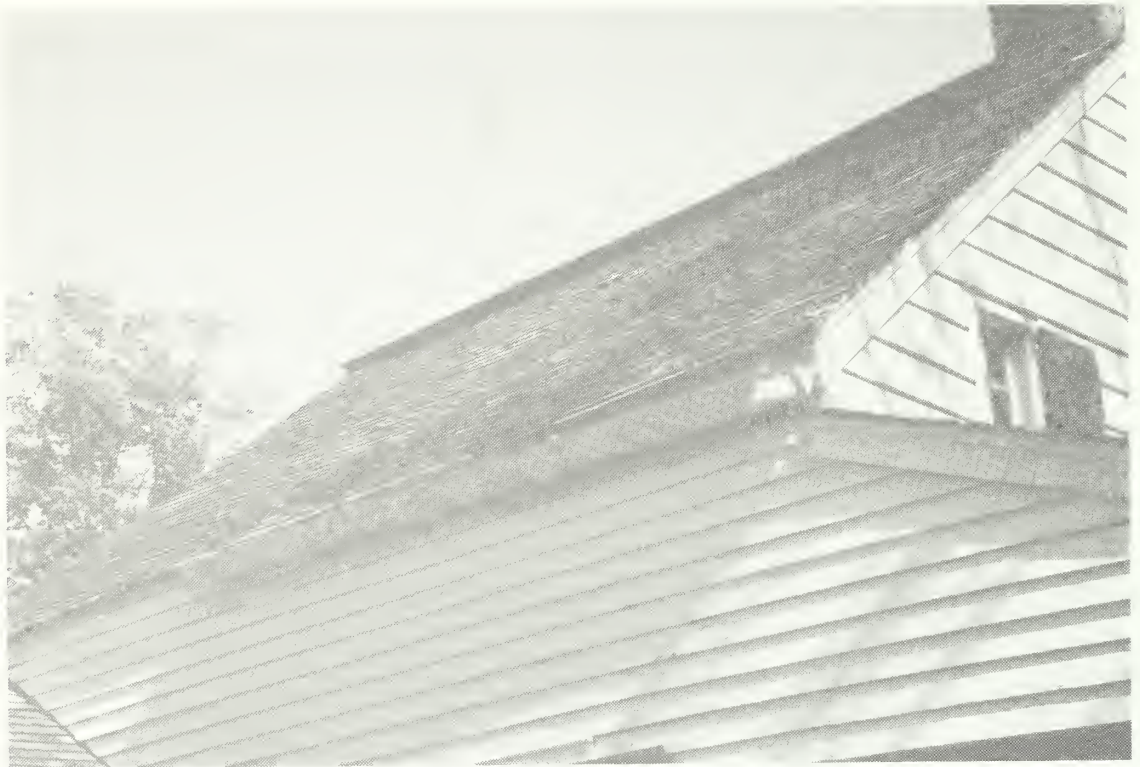
All of the walls of the Schuyler House are covered with clapboards except for the north and east walls of the kitchen wing, which are covered with wide weatherboards. The walls of the main house are trimmed with beaded corner boards 5 inches wide (fig. 132); the walls of the kitchen wing have corner boards 4 inches wide. Molded wood cornices with 5-inch overhangs trim the eaves of the east and west walls of the main house (fig. 128). A verge board 6 ½ inches wide with an ogee molding 2 ½ inches wide trims the gables of the main house and the kitchen wing, the top of the south wall of the kitchen wing, and the rakes and eaves of all of the porch walls. All roofs are covered with wood shingles; the west slope of the main-house roof, and the north slope of the kitchen-wing roof, end in roof combs (fig. 136). Brick chimneys are located at the north and south ends of the main-house roof, and at the east end of the kitchen-wing roof (fig. 101). A restored 19<sup>th</sup>-century privy (not a subject of this report) sits to the east of the kitchen wing.

**Figure 132.** Main house, west façade, north corner board.

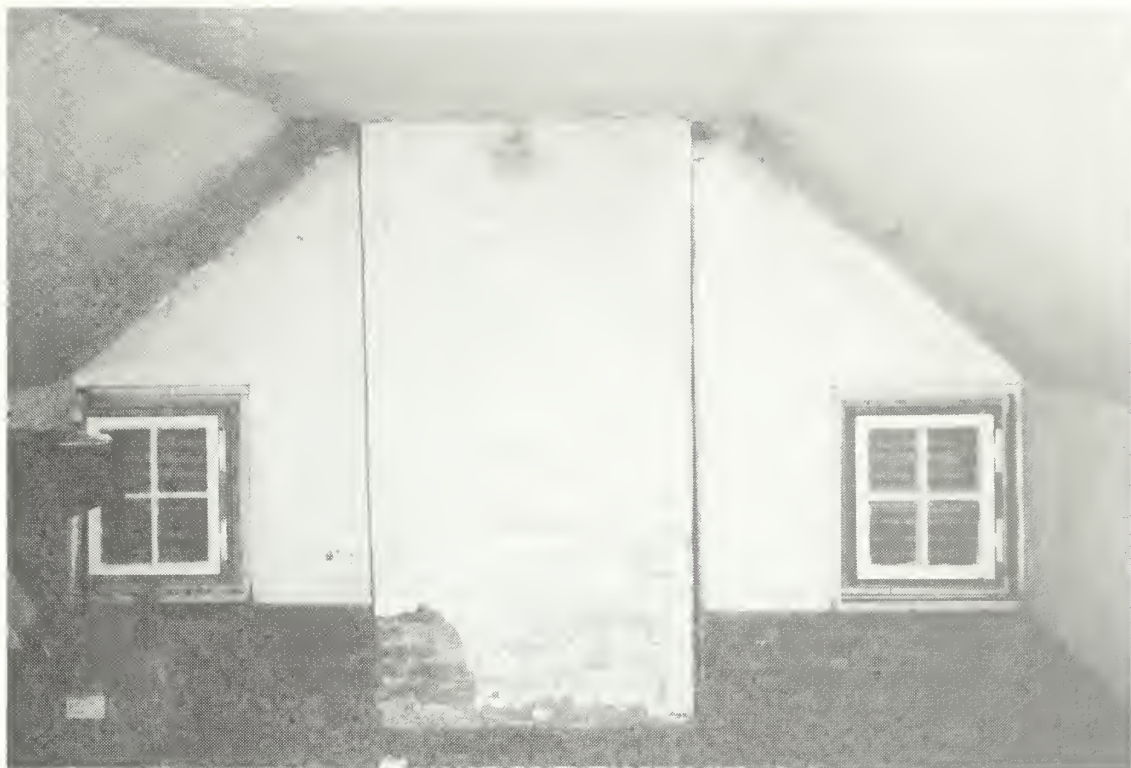
**Figure 252.** North attic room (Room 302), north wall and windows W303 and W304.

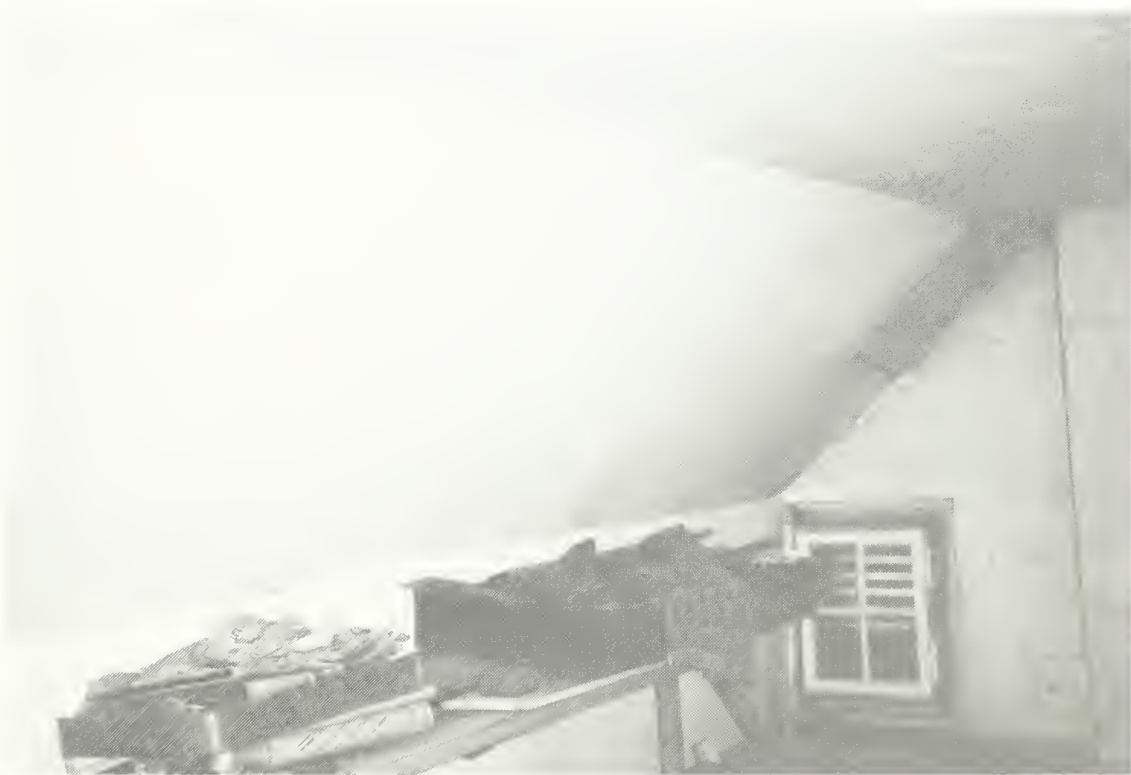
**Figure 253.** North attic room (Room 302), looking northwest.
